# Manhole Inspection Summary

Manhole # S33UU\_011MH

Insp Date: **4/16/07 12:34 PM**

**Location** Address: **2836 MARYLAND AVE**

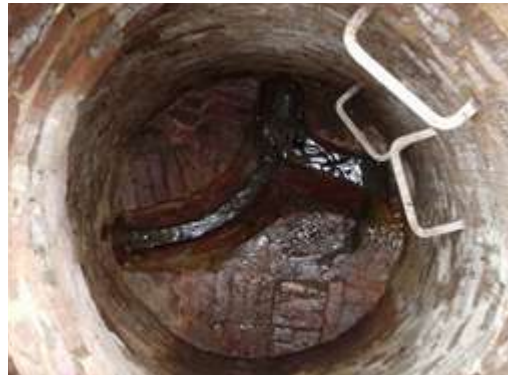
Top View

Evidence of surcharge - Bench debris.

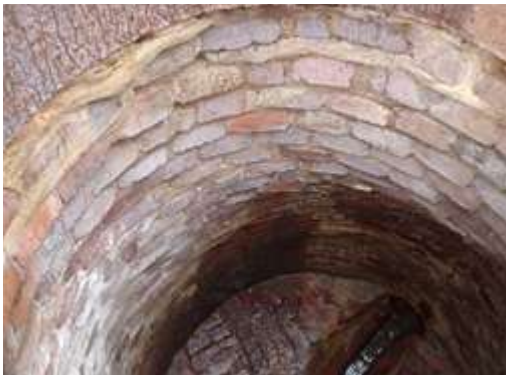
Defect

Frame leaks. Adjustment and Barrel infiltration - other side.

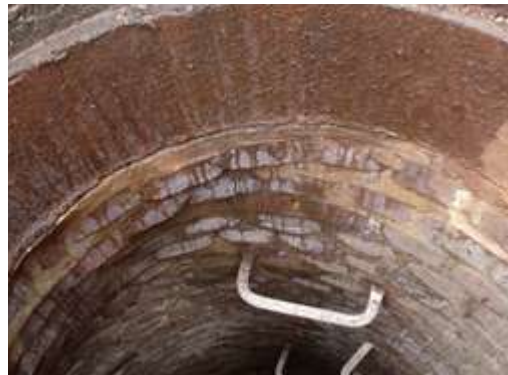
Defect

Frame leaks. Adjustment and Barrel infiltration.

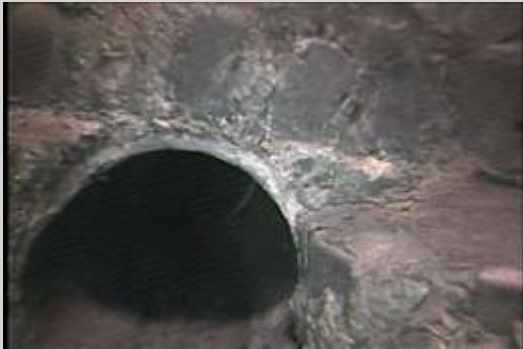
### 8 in. Circular Gravity Sewer Pipe Out @ 12 O'Clock

Pipe Material: **Clay** ☐ Pipe Lined

Invert Depth: **8.14** (ft.) Flow Characteristics: **Slow**

Deposits: ☒ None ☐ Mud ☐ Sludge ☐ Debris ☐ Grease

Infiltration: **None** Pipe Seal Cond: **Unknown**

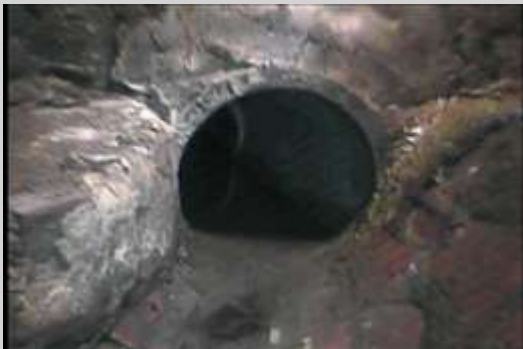
### 8 in. Circular Gravity Sewer Pipe In @ 3 O'Clock

Pipe Material: **Clay** ☐ Pipe Lined

Invert Depth: **7.94** (ft.) Flow Characteristics: **Slow**

Deposits: ☐ None ☒ **Mud** ☐ Sludge ☐ Debris ☐ Grease

Silt Depth: **0.05** (in.) Deposits Extent: **Light**

Infiltration: **Evidence** Pipe Seal Cond: **Unknown**

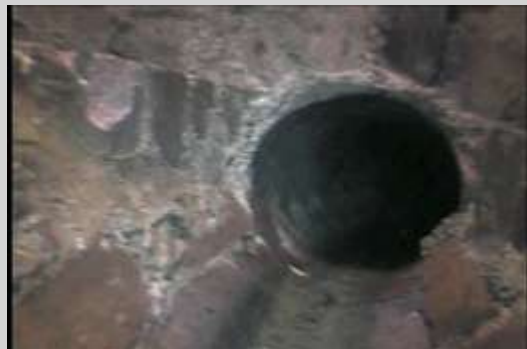
Pipe In @ 9 O'Clock

Pipe Material: **Clay**

Invert Depth: **7.69** (ft.) Flow Characteristics: **Slow**

Deposits: ☒ None ☐ Mud ☐ Sludge ☐ Debris ☐ Grease

Infiltration: **None**
